Asist. Prof. Dr. Serdar Kasap

Bilecik Şeyh Edebali University, Fine Arts and Design Faculty, Department of Interior Architecture and Environmental Design,
Bilecik / TURKEY

Examination of Architectural Heritage Centered Around Bilecik Province

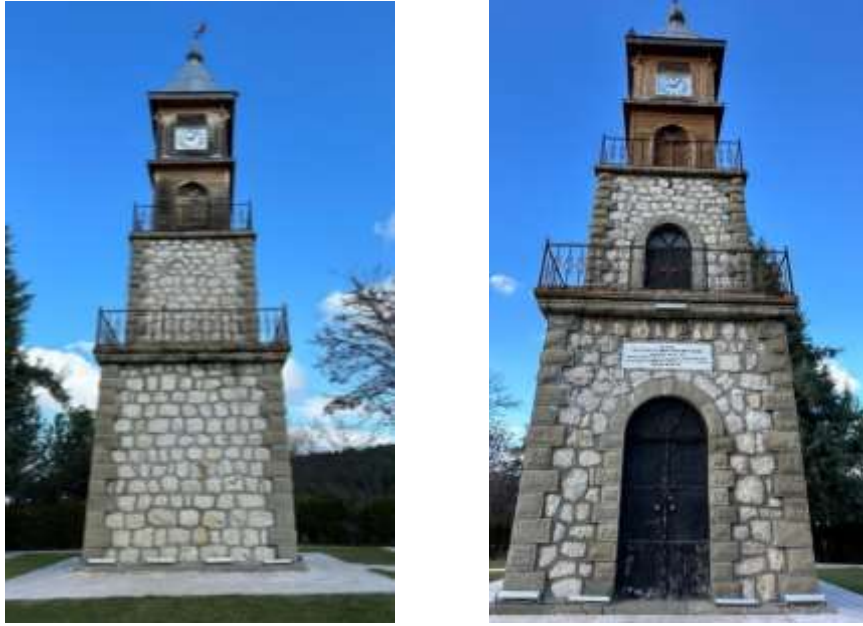
Photo 2. Front View of Bilecik Clock Tower (Left), Side View of Clock Tower (Right)

The Bilecik Clock Tower, shaped like a rectangular prism, features cut stone corners for the first and second floors, with rubble stone used for the facade. The third and fourth floors are made of wood. The entrance to the clock tower is on the west side, using a round-arched, double-leafed rectangular door made of cut stone. There is a section above the door reserved for inscriptions. A similar type of door is also found on the second floor. The first floor features a balcony above it, with no other openings on this level. The third floor, made of wood, sits above the second floor and has a balcony. The balconies are fitted with iron railings. The third floor, entirely made of wood, has single-leafed doors on all four sides. The topmost floor is also made of wood and features a square-dialed clock on all four sides. At its highest point, there is a dome and a flagpole. These architectural features have remained unchanged, making the clock tower a significant part of Bilecik's architectural heritage up to the present day (www.bilecikhaber.com.tr).

The Bilecik Clock Tower was commissioned by Musa Kazım Bey in 1907. The clock tower, which still stands today in 2024, underwent restoration in 1987 and was restored again in 2007, marking its 100th anniversary since construction. The clock tower, with its surrounding landscaping, attracts numerous visitors from within and outside the province (www.aa.com.tr).

Clock towers are categorized according to their architectural plans. They are classified into balcony and non-balcony types, further categorized based on the number and positions of balconies. The Bilecik Clock Tower falls into the category of multi-balcony structures. Among the clock towers that continue to exist today, there are only two multi-balcony clock towers, with another located in Edirne. The Bilecik Clock Tower has two balconies. Balconied clock towers progressively diminish upwards, with each reduction creating flat areas used as balconies (Halaç and İlhan, 2014, p.193). The height of the Bilecik Clock Tower is 20 meters, comprising four floors of a rectangular prism. Access to the upper floors is provided by an internal wooden staircase.

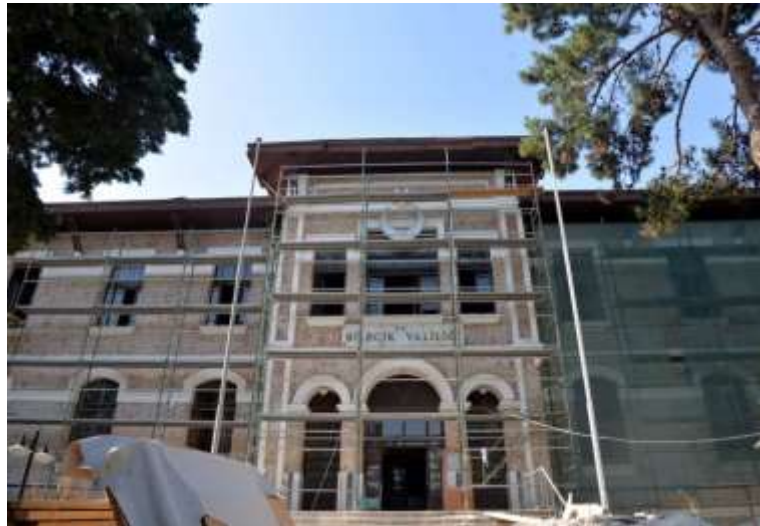
Photo 3. Governorate building restoration works (July 6, 2017) (www.bilecik.csb.gov.tr)

II. Abdülhamit had a considerable interest in Bilecik, which was the Ertuğrul banner territory. His influence was significant in the construction of many works in Bilecik. Compared to its districts, there are fewer architectural heritages in the center of Bilecik. Located in the city center, the building that has served as the Bilecik Governorate for the past 95 years holds a significant place in the concept of architectural heritage, akin to a gateway to the past. Built during the reign of Sultan II. Abdülhamit, the building was destroyed during the War of Independence and was rebuilt between 1922 and 1924 to its present state. Upon examination of its architectural features, the current governorate building is understood to belong to the First National Architecture Period. Over time, the building underwent deterioration but has been reflecting the city's historical texture in modern times through comprehensive restoration efforts conducted between 2017 and 2022 (www.bilecik.gov.tr).

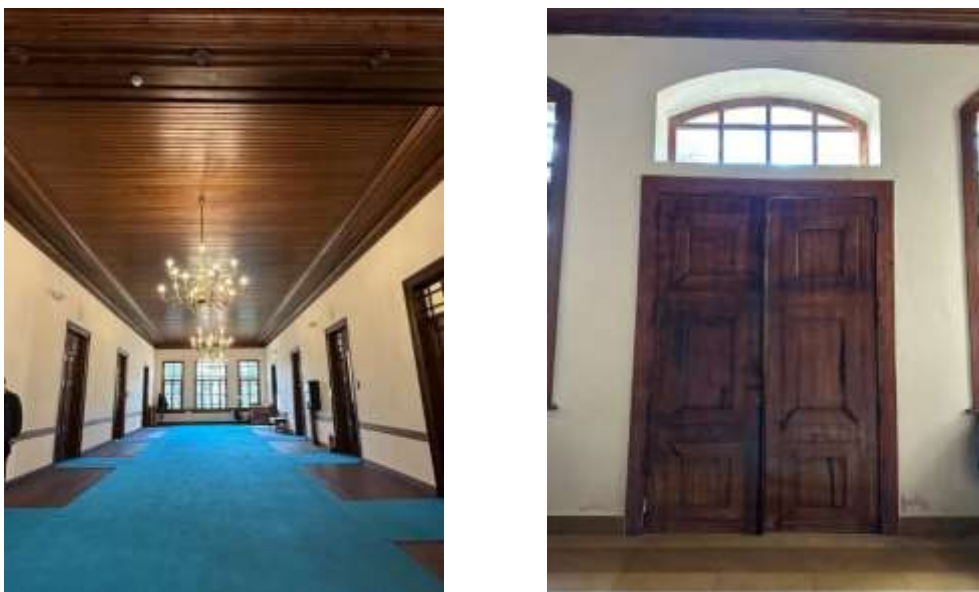
Photo 5. Plan layout of Bilecik Governorate Mansion (Left), Garden Exit Door (Right).

The ground floor features a hall of the same width as the lower floor, with parallel doors opening into rooms, similar to those on the lower level. The structure consists of a basement, ground floor, and first floor. The basement contains 6 rooms, while the ground floor houses 16 rooms arranged in parallel, with 8 rooms on each side. The first floor mirrors the layout of the ground floor. The architectural design is centered around a spacious hall, with doors opening from the hall to the rooms, extending symmetrically to the right and left. The building is perfectly symmetrical when divided down the middle. There are exits to the garden from the right and left side facades, each with doors arranged in parallel. When examining buildings from this period, there are many structures with similar architectural layouts to the Bilecik Governorate Mansion (Çolak and Erarslan, 2021, pp. 206-207).

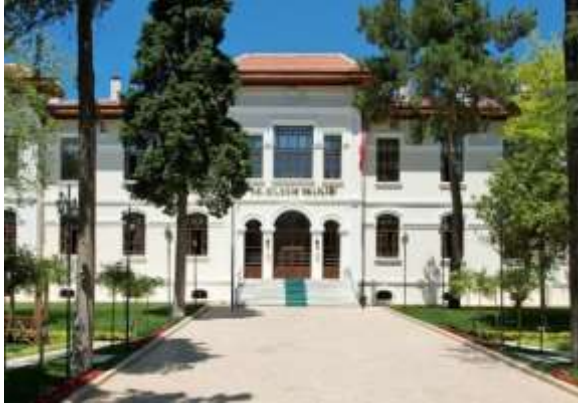
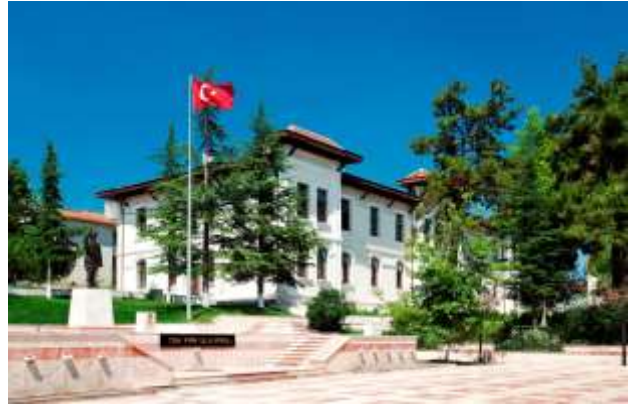
Photo 6. Front View of Bilecik Governorate Mansion (Left), Left Side View (Right).

Constructed as a rubble masonry building, the governorate mansion reflects the architectural influences of its time in its facade design. Influenced by the national architectural movement, the facade features arched windows and doors, while the upper windows are rectangular. Access to the entrance is through 10 steps leading to a large wooden door flanked by two small arched doors on either side. Similarly, windows above these doors are arranged with two small wooden windows on either side of a larger central window. The windows on the front facade of the building are identical on both the left and right sides. Arched wooden mullioned windows are on the ground floor, with five on the right and five on the left. On the

upper floor, the windows are again arranged with wooden mullions, but in a rectangular shape rather than arched, aligned with those on the ground floor. The basement floor has small arched windows that are similarly aligned. The side facades feature double-winged wooden doors leading to the garden, with small windows beside them, matching the size and alignment of the upper-floor windows directly above the doors. The side facades mirror each other. The rear facade also follows the same window arrangement. In the middle, the gallery space features tall, narrow windows extending from the ground to the first floor. When viewed, the facade of the building divides symmetrically like a butterfly wing. The window arches of the cream-colored building are white. All doors and windows are wooden and have large openings.

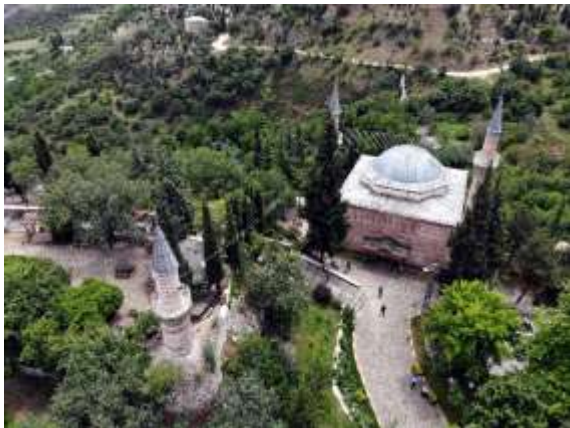
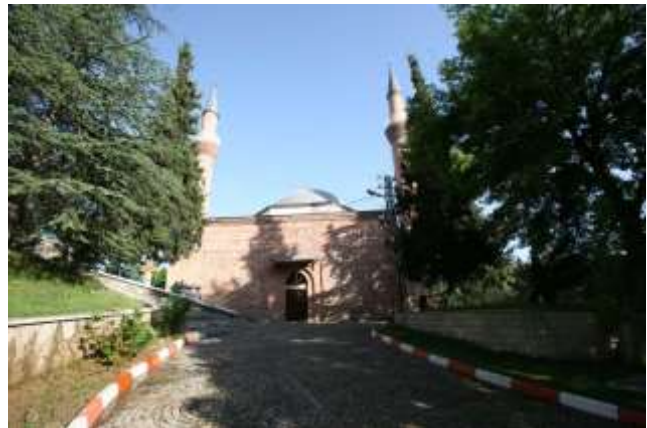
Photo 7. Orhan Gazi Mosque in Bilecik (www.x.com).

The mosque, designed in a close-up square format, has a simple plan measuring 17.35x16.50 meters. The last congregation area of the mosque has not survived to the present day.

The Orhan Gazi Mosque holds significant importance for Bilecik. Although the exact date of its construction is unknown, it is believed to have been built in 1331. The mosque, which underwent restoration in 1814 during the reign of Sultan Mahmud II, has its original minaret located on the rock 30 meters away. In 1889, during the reign of Sultan Abdulhamid II, additional restoration work was carried out, and twin minarets were added. These minarets are not particularly suited to the mosque's architectural style. The mosque, which has also undergone restoration and repair works in 1973 and 2023, reopened its doors in the 724th year of the conquest of Bilecik. As one of the oldest structures in Bilecik's architectural heritage and an important cultural tourism site, the mosque is never without visitors, especially due to its proximity to the Edebali Tomb, located just 75 meters away (www.islamansiklopedisi.org.tr).

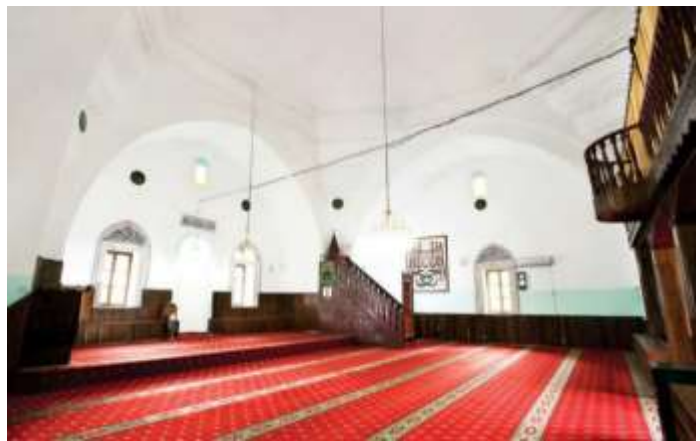
Photo 9. Orhan Gazi Mosque Plan (www.okuryazarim.com)

Among the monumental works of Ottoman architecture, the body walls of the mosque were hollowed out to a depth of 2.40 meters to expand the interior space, creating a wall appearance with depth rather than a solid wall. Thick body walls formed at the corners enabled the construction of a domed roof with a flattened dome measuring 9.50 meters in diameter.

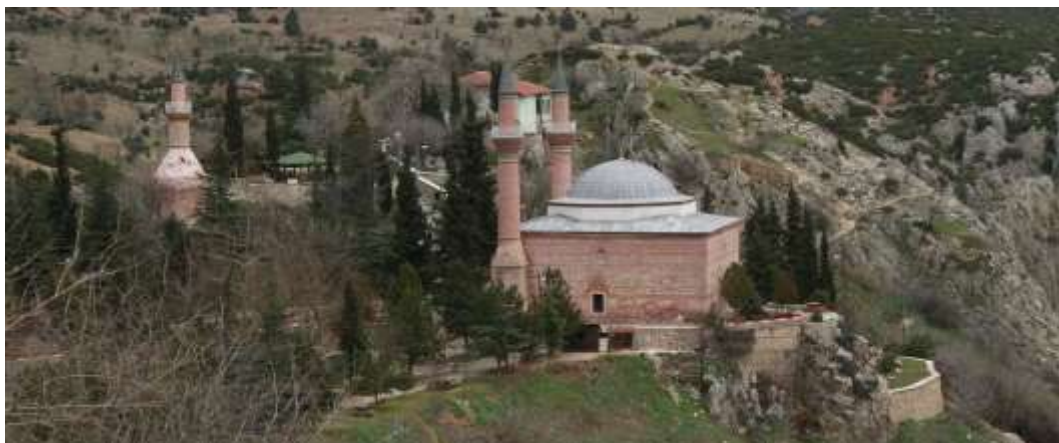
Photo 10. Bilecik Orhan Gazi Mosque Front View

The mosque has high pulpit-like, cylindrical-bodied, single-gallery stone minarets on either side of its front facade. These minarets are not present in the 1882 dated photographs, suggesting they were later constructed along with the wooden last congregation area. The mosque, designed with a simple plan, has an arched entrance provided by a double-winged wooden door. The corners of the minarets are built of cut stone and brick, giving them a different appearance from the mosque, indicating that the minarets were added later. The mosque's right, left, and rear facades feature arched brick-built, but plain wooden lattice windows. The last congregation area is wooden, with its ceiling decorated with wooden laths (Solak, 2023, p. 8).

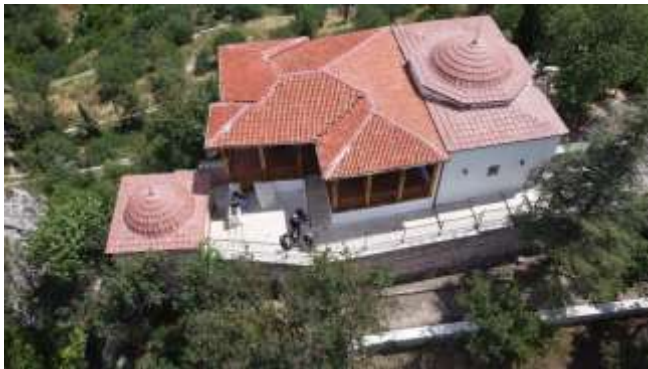
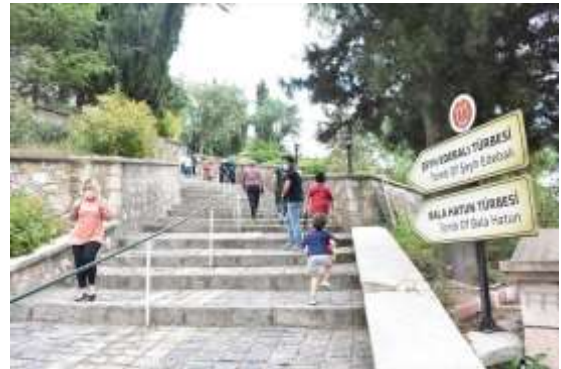
Photo 11. General View of Şeyh Edebâli Tomb (Left), Stairs of Şeyh Edebâli Tomb (Right) (www.ensonhaber.com).

Due to its location on a hill, the tomb is open and constantly receives sunlight. The tomb is accessed by steep stone stairs. The Şeyh Edebalı Tomb, mosque-monastery and shaykh's lodge, oriented north, are aligned in an east-west direction in an open-fronted wooden columned hall; separately constructed from them, the Mal Hatun Tomb is located in the eastern part of the hall. It is evident that the walls of the tombs built with rubble stones are connected to the main construction period of the mosque-monastery, and the Baghdad wall style shaykh's lodge took its final form in the 19th century. The Şeyh Edebalı Tomb, located at the western end of this mass, has a rectangular plan developed in the qibla direction. The tomb is covered with a low dome between two barrel-vaulted iwans. The only decorative element seen in the tomb is the plaster window in the classical style from the 16th or 17th century crowning the window on the south wall. Adjacent to the east wall of the tomb-monastery, which opens to the hall, is a nearly square rectangular plan and a smaller space than the tomb. A window has been placed on both sides of the mihrab to the north and south of the door. Above the door opening to the hall, the tughra of Abdülhamid II and the date 1307 can be seen. The plaster window crowns in the Empire style wood ceiling, which is likely from the second quarter of the 19th century, are more recent than those in the tomb.

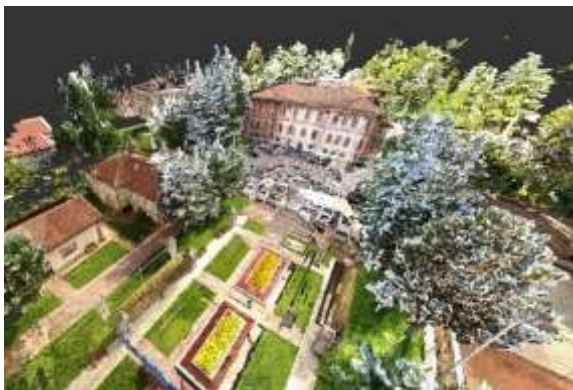
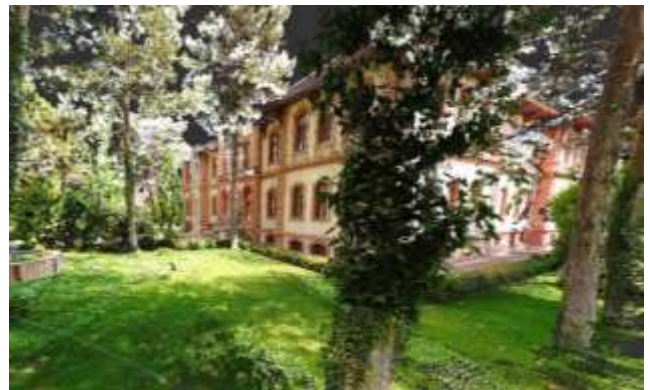
Photo 12. Secondary School, Point Cloud View (from the survey conducted in 2019)

Secondary School As a result of the modernization movements initiated by Sultan Mahmud II, secondary schools began to emerge towards the end of his reign (Bilirli, 2021, p. 3838). Accordingly, upon the proposal by the Meclis-i Umur-ı Nafia established in 1838, it was decided to open new schools initially named Sınıf-ı Sani, later renamed Rüşdiye, to educate students beyond elementary education (Demirel, 2011, p. 16). The Rüşdiye school of Bilecik is the Ertuğrul Province Rüşdiye. The building constructed in 1905 currently serves as the municipality building. It was liberated from Greek occupation on September 6, 1922. However, upon leaving, the Greek army caused significant damage to the city. The Greek army that set fire to the city also largely burned and destroyed the Ertuğrul Province Rüşdiye. Therefore, there is not much information available prior to 1922 (www.meb.gov.tr). As part of architectural heritage, a survey has been conducted to transfer and preserve the building for future generations. In documenting the structure, traditional and optical methods were combined. Thus, three-dimensional models were produced; plans, elevations, sections, and details were extracted ready for drawing with measured precision, and two-dimensional architectural drawings were produced in digital format. Subsequently, each space of the building, its architectural elements, and surroundings were meticulously documented through detailed photography.

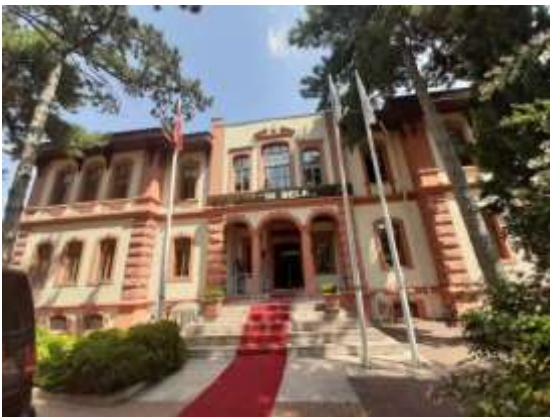
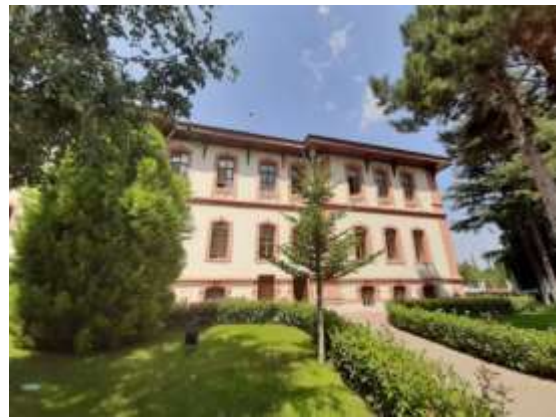
Photo 15. Rüştüye School / Bilecik Municipality Service Building West Facade (Left), South Facade (Right).

The main entrance facade of the building faces west. The facade, approximately 2920 cm wide, rises to a height of about 1010 cm at the eaves level. Massively, the facade protrudes forward in three parts and recedes. The northern part of the facade, approximately 777 cm wide, and the southern part, also 777 cm wide, are about 75 cm further forward than the middle section. In the middle, a staircase rises in three directions, emphasizing the main entrance, leading to an outer entrance hall defined by three semi-circular arches supported by two stone columns. This arched decoration is positioned 30 cm forward from the wall surfaces of the central section. Above the arched section, there are three flat-arched wooden windows, with decorated jambs flanking the central double-winged wooden door. Above the arched entrance section, the central part features a higher pediment-like jamb decoration, while the sides have simpler flat-arched wooden windows with upper eaves cornices. The projecting masses on the north and south sides of the facade are symmetrical to each other. On both sides, there are nine flat-arched windows each at the level of the upper floor, ground floor, and basement level.

The south facade of the building is approximately 3063 cm wide and rises to a height of about 1055 cm at the eaves level. The facade, considered as three parts in mass, has the eastern and western parts protruding more than the middle section. The facade features stone stringcourses at the level of basement windows, ground floor flooring, and upper floor flooring, all plastered and painted. In the western part, at the corner of the west facade, there is a beaded corner cornice visible on the west side of this mass (the projecting part), while the corner cornice remaining in the east corner of this mass is straight-lined and undecorated. This mass also includes nine flat-arched windows each at the level of the upper floor, ground floor, and basement level. In the remaining eastern part of the front parts, there are also nine flat-arched windows each at the level of the upper floor, ground floor, and basement level. However, unlike the western side, the basement windows are longer. In the center of the facade, set further back, there are four windows at the upper floor level and four at the ground floor level, with four openings in the basement, two of which are windows and two are doors. However, traces around the doors suggest that these were originally window openings enlarged to create doors. Under the eaves, there are modern wooden buttresses: four in the western part, three in the middle, and four in the eastern part.

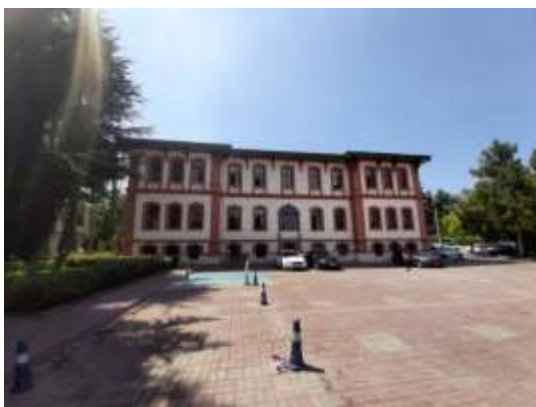
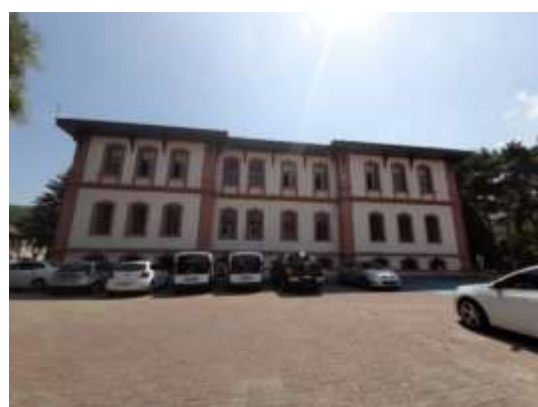
Photo 16. Rüştüye School / Bilecik Municipality Service Building East Facade (Left), North Facade (Right).

The east facade of the building can also be read in three parts massed like the south facade. It is approximately 2940 cm wide and rises to approximately 1116 cm in height at the eaves. On the facade, there are plastered and painted stone string courses at the basement window level, ground floor slab level, and upper floor slab level. The masses on the north and south of the facade are more prominent compared to the central mass. Both the northern and southern corners of the northern part have plain, undecorated corner cornices. This mass has nine depressed-arched windows: three at the upper floor level, three at the ground floor level, and three at the basement level. The prominent mass in the south also has the same features as the northern part. The corners of this mass in the south have plain, undecorated corner cornices similar to those in the north. This mass also features nine depressed-arched windows: three at the upper floor level, three at the ground floor level, and three at the basement level. The first-floor windows in this section have sills, with rectangular insets below the sill and jambs where the keystone is raised above the arch. The ground floor sills do not have under-sill decoration, only the keystone is raised. The basement sills are made of rusticated stone with rectangular relief above the keystone. There are also preserved wooden struts under the eaves: four in the southern part, four in the central part, and four in the northern part. The entire facade is plastered and painted. There are scattered paint losses and damp spots below the basement string course.

The northern facade of the building resembles the southern facade. The parts on the east and west sides of the facade, which can be considered as three parts massed, are more prominent than the central part. On the facade, there are plastered and painted stone string courses at the basement window level, ground floor slab level, and upper floor slab level.

In the western part, there is a rusticated corner cornice seen on the western corner of the western part; the eastern corner cornice of this mass (the prominent part) is plain and undecorated. This mass also has nine depressed-arched windows: three at the upper floor level, three at the ground floor level, and three at the basement level. The first-floor windows in this section have sills, with rectangular insets below the sill and jambs where the keystone is raised above the arch. The ground floor sills do not have under-sill decoration, only the keystone is raised with a rectangular relief on this stone. The basement sills are made of rusticated stone. The eastern prominent part of the facade also has nine depressed-arched windows: three at the upper floor level, three at the ground floor level, and three at the basement level. However, the basement windows are longer than those in the west. The first-floor windows on the facade have sills, with rectangular insets below the sill and jambs where the keystone is raised above the arch. The ground floor sills do not have under-sill decoration, only the keystone is raised with a rectangular relief on this stone. The basement sills are made of rusticated stone. In the central mass, there are four windows at the upper floor level, four at the ground floor level, and four at the basement level. The first-floor windows in this section have sills, with rectangular insets below the sill and jambs where the keystone is raised above the arch. The ground floor sills do not have under-sill decoration, only the keystone is raised with a rectangular relief on this stone. The basement sills are made of rusticated stone. The entire facade is plastered and painted. There are preserved wooden struts under the eaves: four in the western part, four in the central part, and four in the eastern part (These informations are taken from the survey study conducted in 2019).
